# Photogrammetry Measurements During a Tanking Test on the Space Shuttle External Tank, ET-137

# Background - Motivation

- Cracks in TPS insulation found on November 5<sup>th</sup>, 2010, following a scrub related to leaks in the Ground Umbilical Carrier Plate (GUCP)
- Decision was made to use 3-D photogrammetry for root-cause investigation during a tanking test

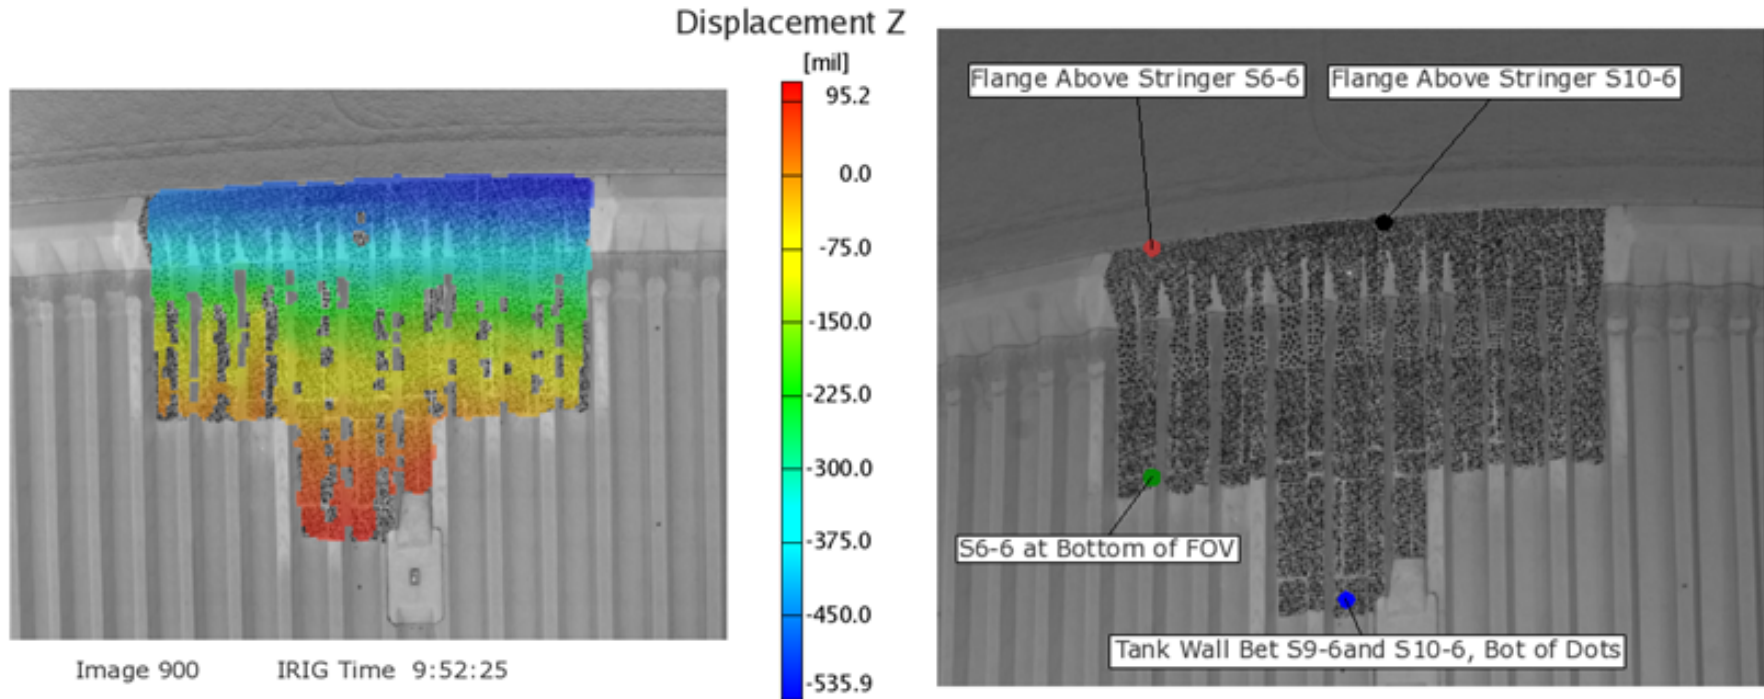
- Fringe plots show inward contraction of the L02 tank above the flange
- Fringe analysis also used to pick points for time history data extraction

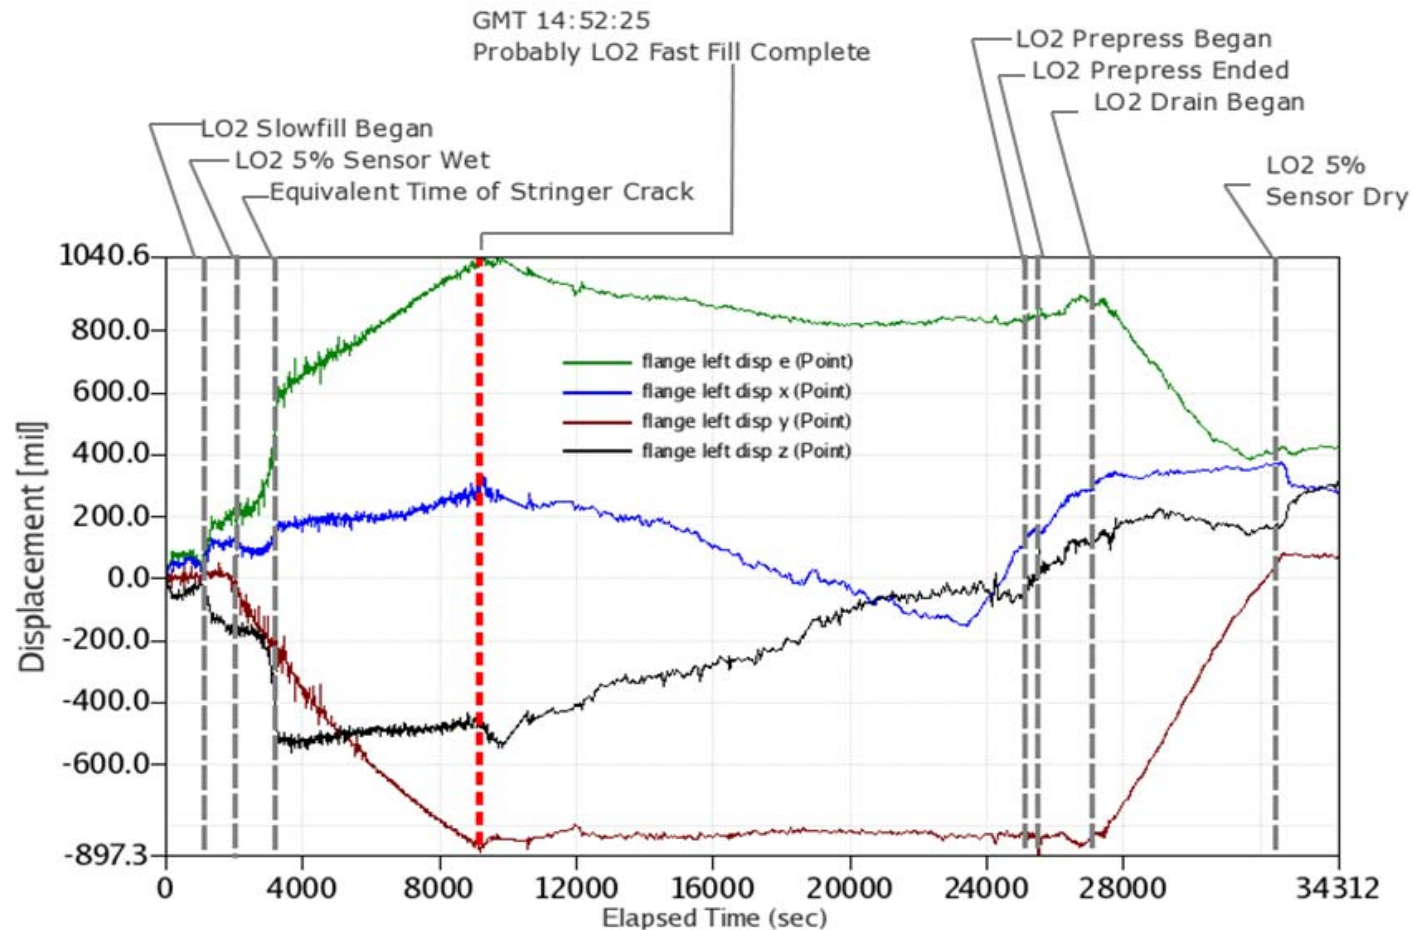
- Large amounts of negative displacement suggests that the ET is sagging due to the propellant being loaded
- Significant event times are highly noticeable

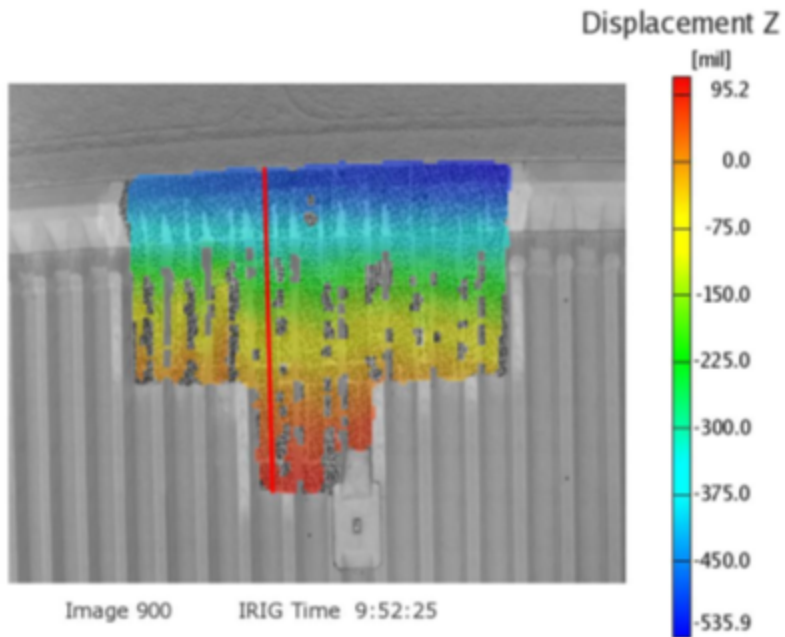
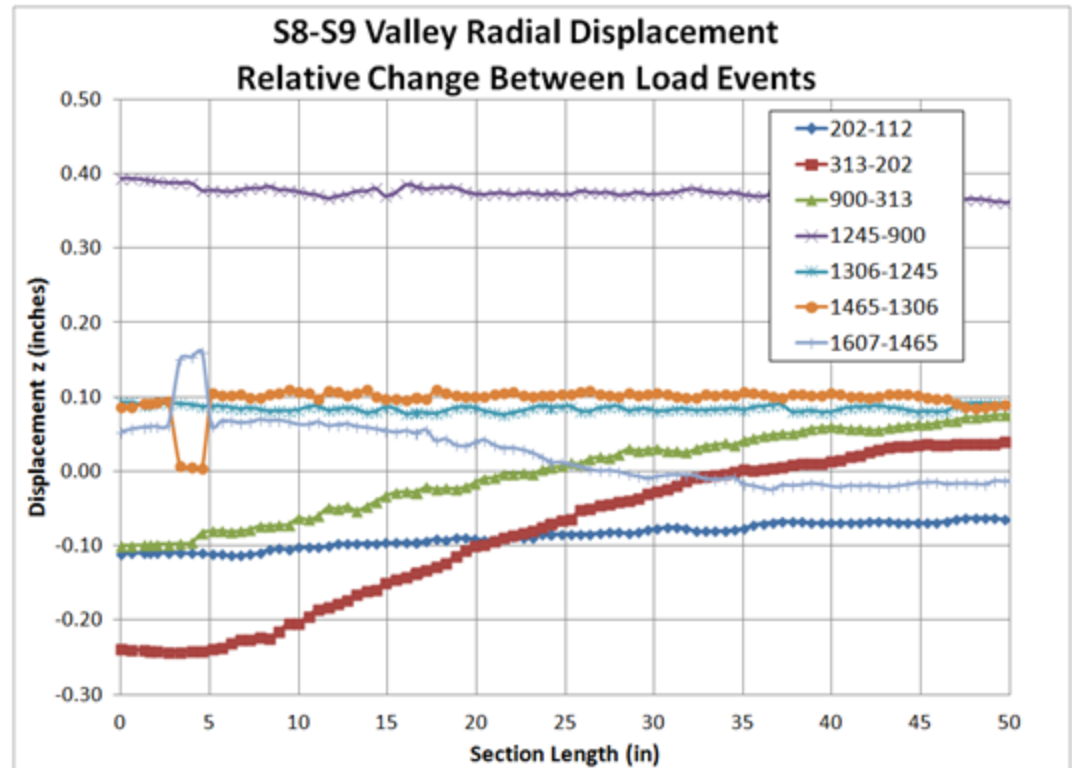
- Plots as a function of position
- Plot shows time differences of data as a function of position
- The “flatness” of the line shows rigid body motion
- Large amount of ET deformation up through filling (image 900) indicated by large slopes in lines

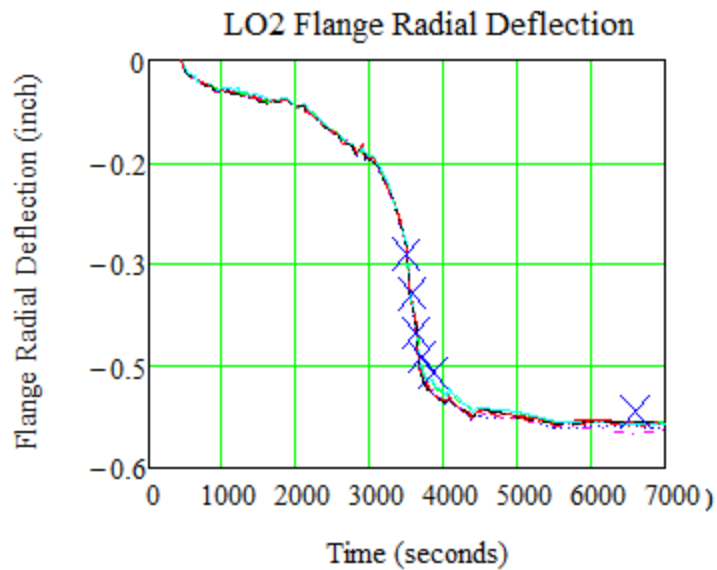
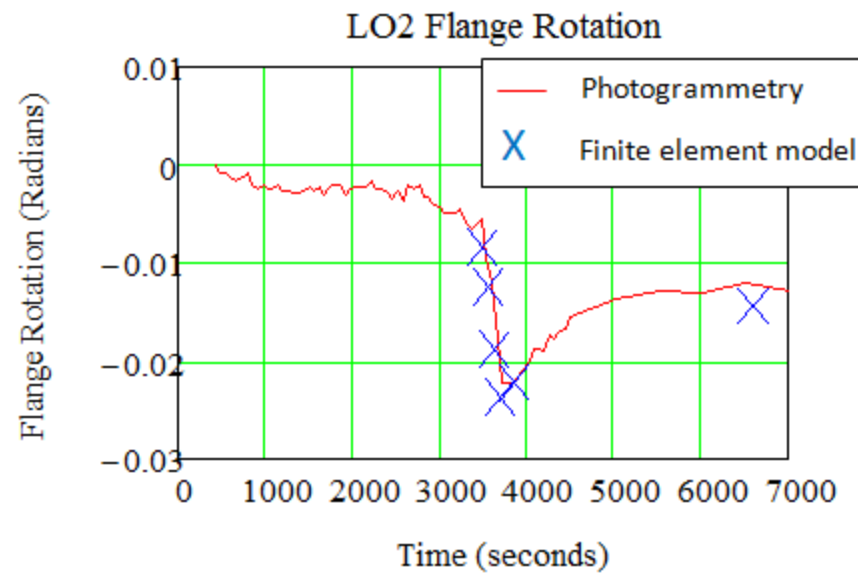
- Flange deflection and rotation are compared throughout the time history
- Shows excellent agreement and has been used to validate ET FEMs
- A complete analysis has been completed by MSFC
