# Photogrammetry Measurements During a Tanking Test on the Space Shuttle External Tank, ET-137

# Background - Motivation

- Cracks in TPS insulation found on November 5<sup>th</sup>, 2010, following a scrub related to leaks in the Ground Umbilical Carrier Plate (GUCP)
- Decision was made to use 3-D photogrammetry for root-cause investigation during a tanking test

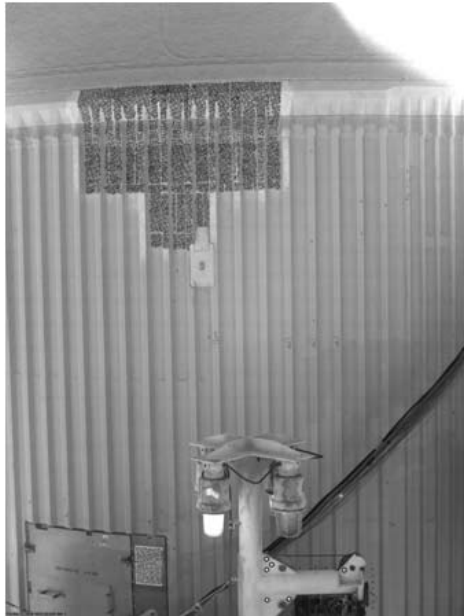
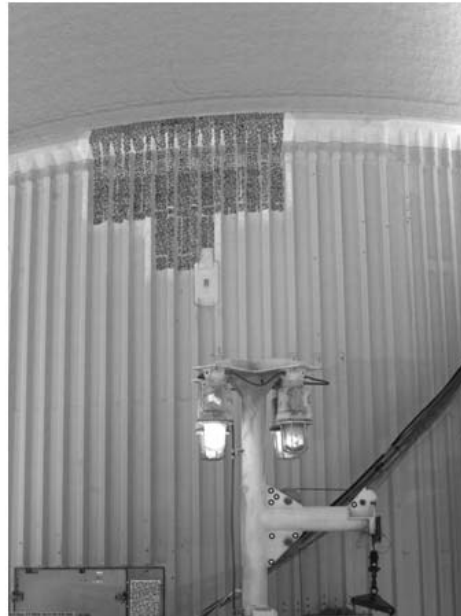
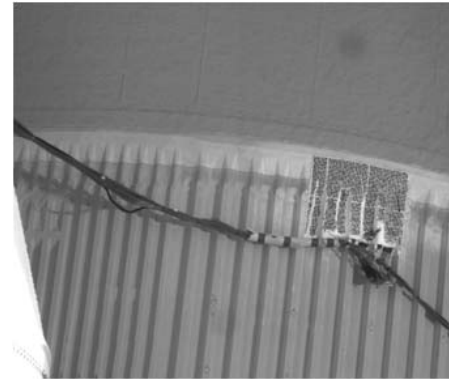
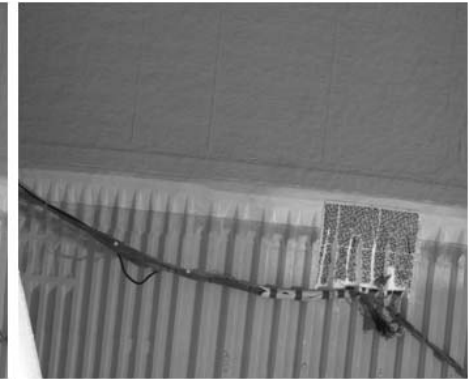
- Cameras image re-exposed due to changing sun conditions
  - Upper left of Left cam Panel 6
- Dot pattern coverage severely reduced from the original camera field of view due to flight safety concerns

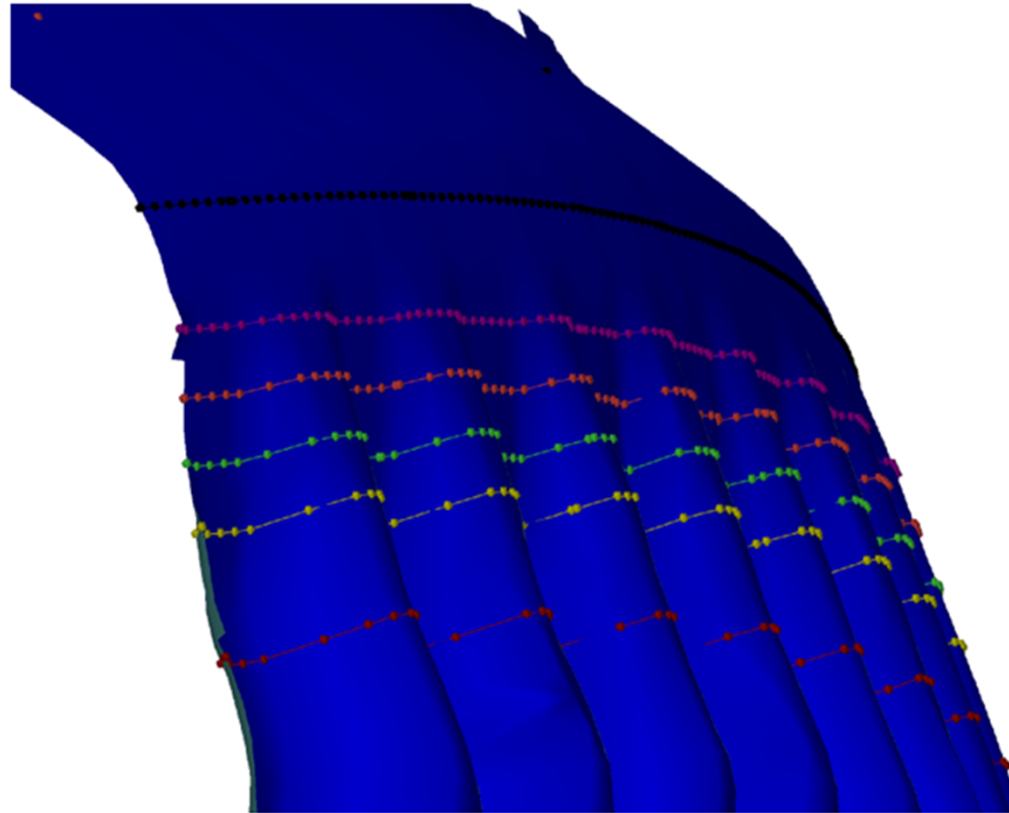
- Qualitative first check at the data
- Determine overall “shape” of tank
